PRODUCT SERVICE ADVISORY & TECH NOTE

PowerFlex 40: Mandatory Product Service Advisory Type-II Product Upgrade/Exchange
PowerFlex 4: Tech Note Discretionary Customer Satisfaction Action

PowerFlex 4/40 Reflash Issue

Ref: CPAG 2004-07-002

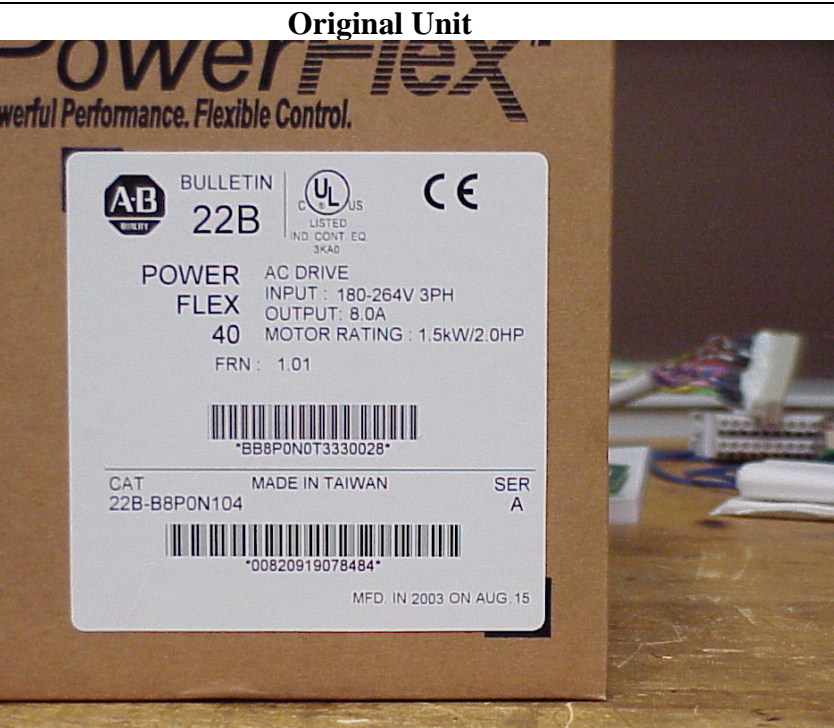
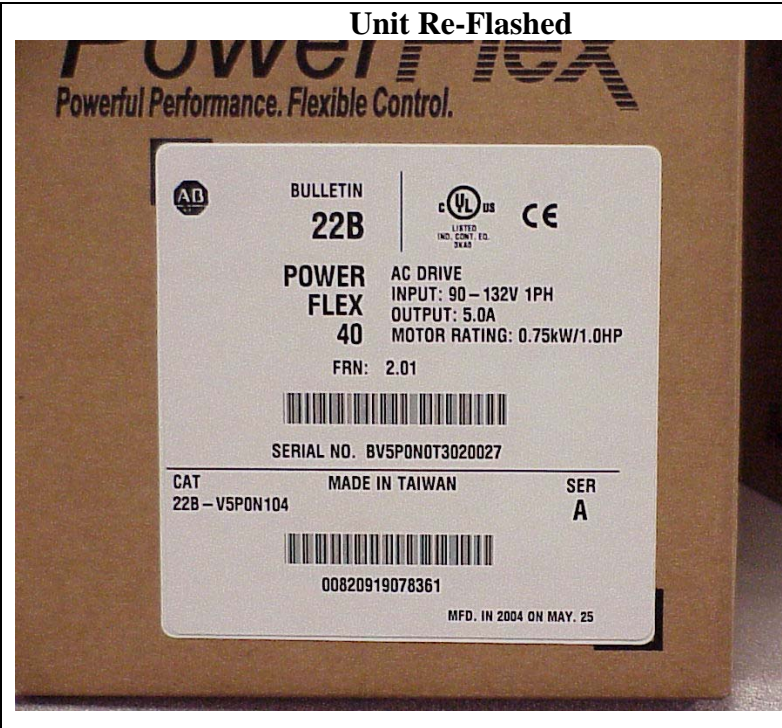
Affected units may be identified by the carton labels displaying Firmware Revision Number 2.01 (for PowerFlex 40) and 3.05 (for PowerFlex 4) it also reflects the small

“A-B Logo” in the upper left hand corner. The attached pictures reflect a factory shipped unit versus a re-flashed unit.

Examples of carton labels prior and after re-flash:

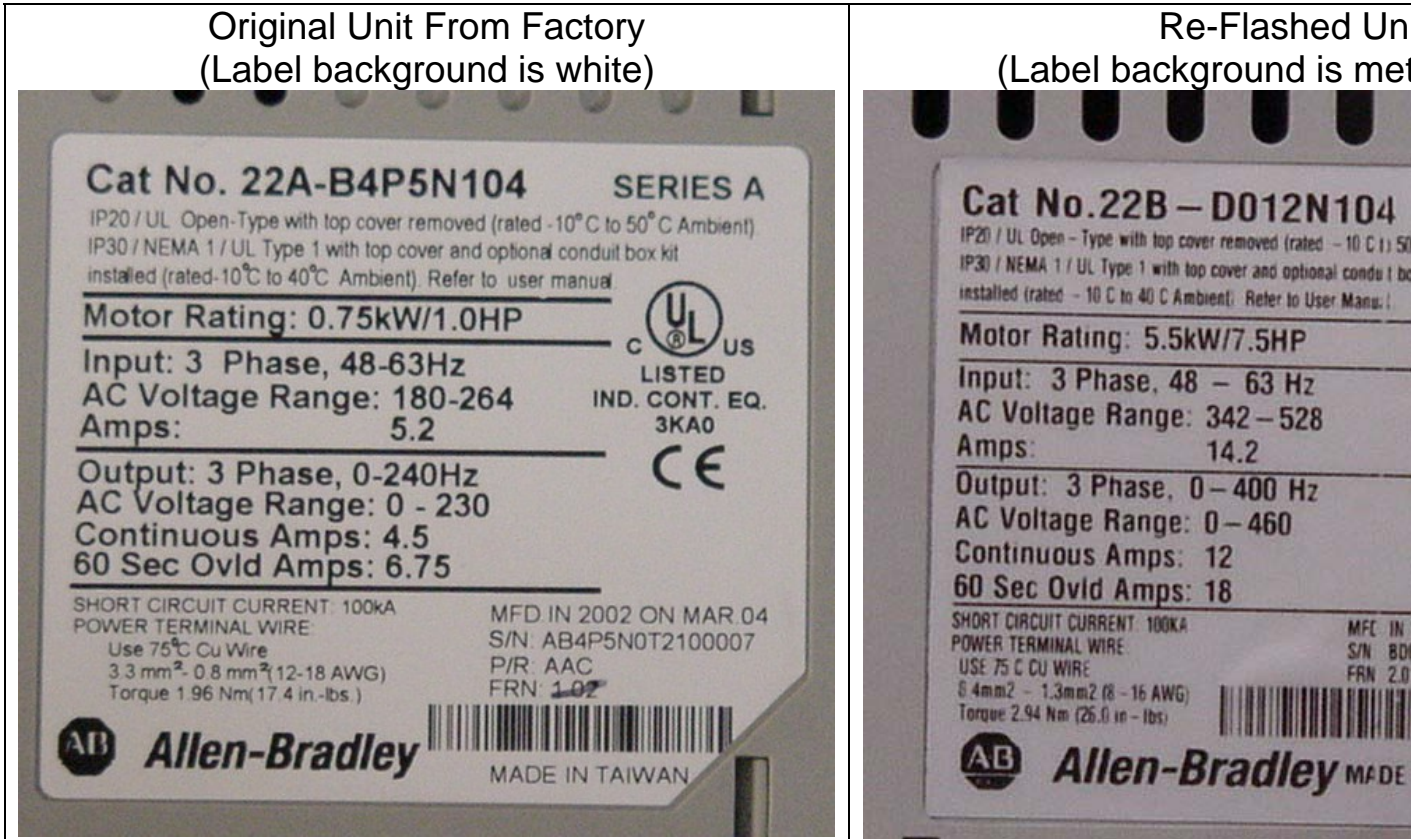
If affected drives were shipped to customers, the drive nameplate label will be metallic silver instead of the standard white label.

Examples of Product Name Plate prior and after re-flash:

PowerFlex 40 drives, replacement will be under warranty. The affected unit must be returned via PSR referencing “PF40 Product Service Advisory”.
