# DriveLogix™ 5730 Controller (15.03)

Catalog Number 5730

These release notes should be used with DriveLogix5730 Controller firmware major revision 15, minor revision 3. Use this firmware with:

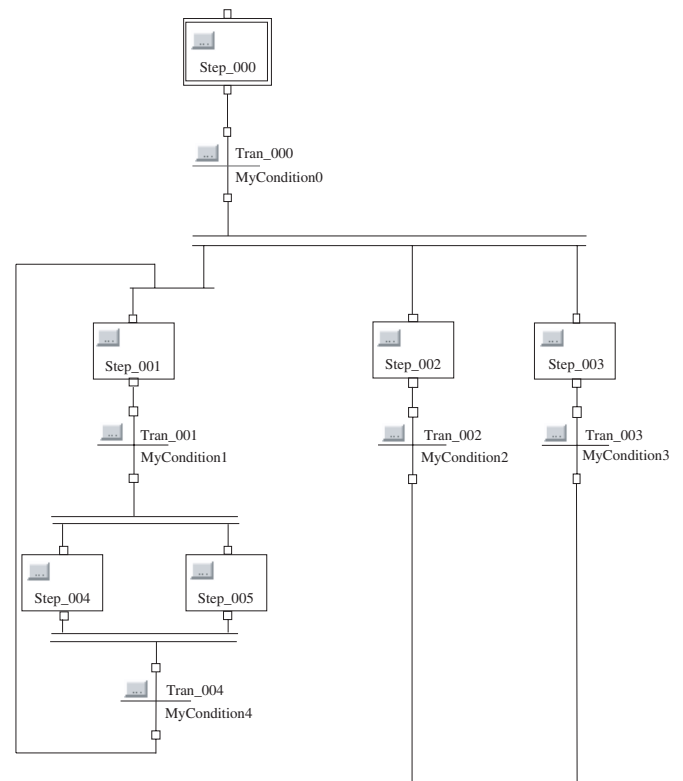
An SFC Could Execute the Wrong Step

If you had an SFC with nested simultaneous branches, the controller could begin execution at an unexpected step. Following the convergence of a nested simultaneous branch, if the SFC looped back to the initial step of the parent branch, instead of executing that step, the SFC could jump to a step of another path in the nested simultaneous branch. For example:

Execution starts at Step\_000. When Tran\_000 becomes true, Step\_001, Step\_002 and Step\_003 should become active. However, because the nested simultaneous branch in the left path converged and looped back to its parent step (Step\_001), the active steps were actually **Step\_005**, Step\_002 and Step\_003.

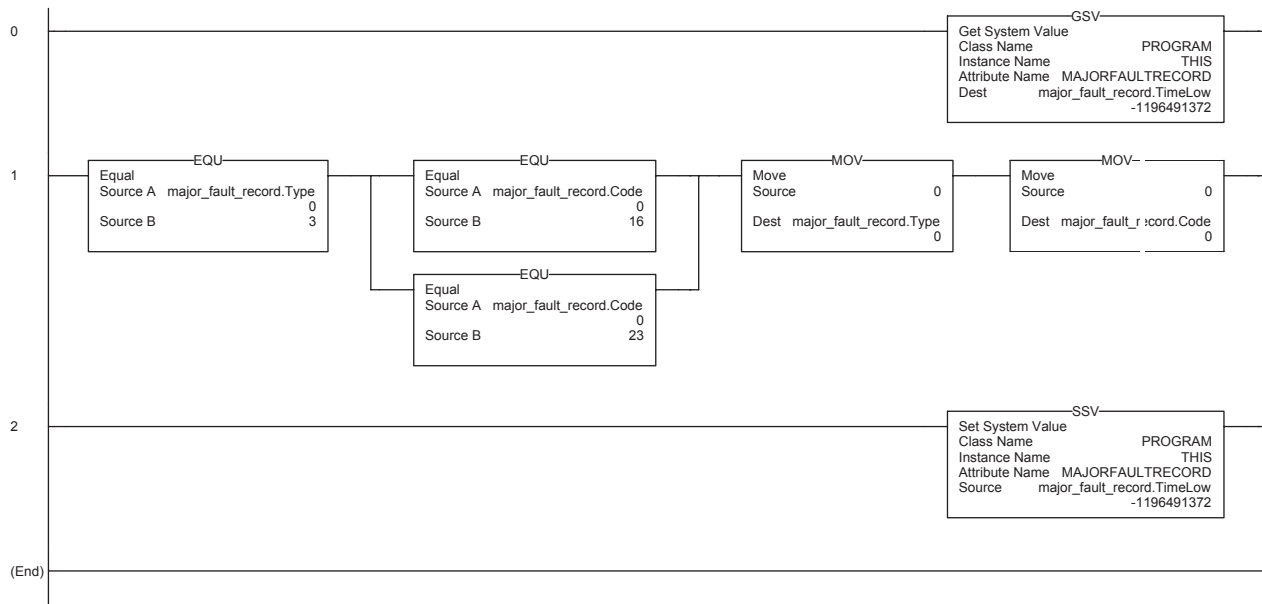
Use fault routine to clear fault from local I/O which is generated when controller and I/O are powered down.

When powering down the controller (the host drive) and I/O banks simultaneously, the controller will stay energized slightly longer because the drive's DC bus indirectly powers the controller. In some instances this generates a fault because the controller stays energized long enough to recognize a connection failure. A routine can be exploited to clear this fault. This routine is part of the Power-Up Handler in the RSLogix 5000 project. Use a fault routine like the one below to clear this fault:

**Note:** The use of this fault routine will cause the controller to power up in the Program Mode.
