DriveLogix™5730 Controller Firmware Revision 17

Catalog Number 5730

About Publication 20D-RN038C

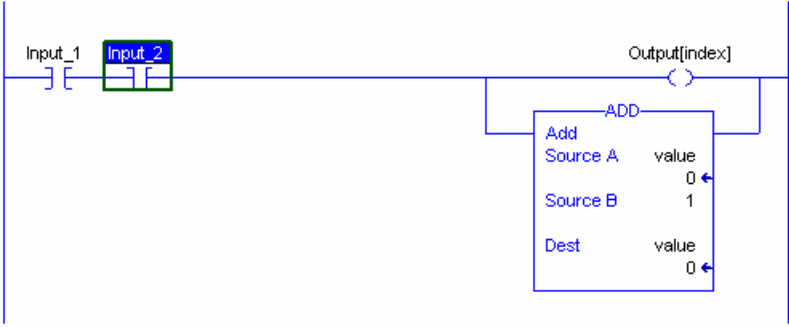
Anomaly	Description
<p>Fault handler anomaly</p>	<p>Fault handlers can be defined at the controller and program scope levels. These fault handlers are typically used to handle major recoverable faults that can occur during runtime execution of an application due to programming errors. A typical example of this would be handling indirect addressing that has gone out of range; MyTag[index], where index is larger than the size of the array.</p> <p>Faults can also be handled by the controller during pre-scan of the controller program on the transition to Run mode. Again, for example, the handling of indirect addressing that has gone out of range.</p> <p>There is an anomaly when these methods attempt to handle a fault.</p> <p>These are the possible ways the anomaly can manifest itself:</p> <ul style="list-style-type: none"> • The controller will experience a major non-recoverable fault. I/O goes to their configured safe state, and the user application is cleared from memory. At this point, a Code 1 Type 60 or 61 major recoverable fault will be logged in the controller. This requires you to redownload the application. • Tag data corruption. • Online saving or uploading failures. • Anomalous program execution. <p>For example, if a rung is being scanned false and there is an instruction that has false execution, the fault handler executes so the remainder of the rung will scan true. In the example below, the OTE instruction has an index out of range. After returning from the fault handler, the ADD instruction will execute, even though the rung input conditions are false.</p>

<p>Lgx00106482, Lgx00100765, Lgx00097014</p>
