1395 Troubleshooting Guide

Malfunctions Not Indicated by a Fault

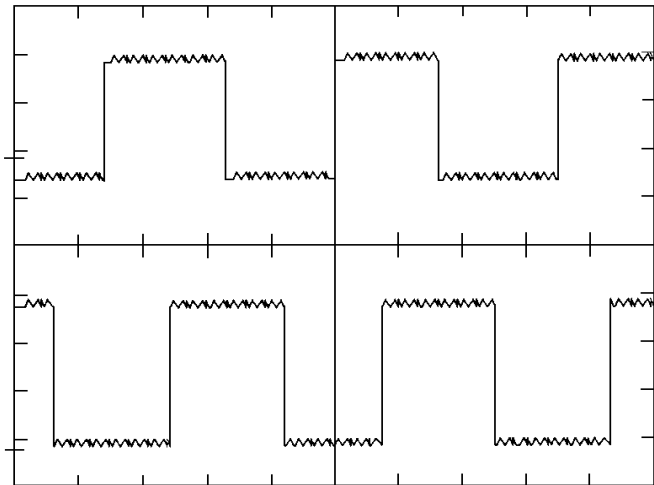
Figure 3.1
Waveform 1 - Encoder Phases A (TP15)
and B (TP12), Forward (CCW)

Solution: Open the drive door and lower the Main Control Board assembly. Locate test points TP12 and TP15 on the left side of the board near U13. TP12 is the phase B signal and TP15 is the phase A. Verify that proper quadrature exists between A and B. Rotate the motor in the CCW direction, as viewed from the commutator. The resulting waveform should be similar to Waveform 1 shown in Figure 3-1. If the encoder signals are in phase or 180 Deg out of phase, check the wiring to ensure that the signal lines are not shorted. If the wiring is functional replace the encoder.

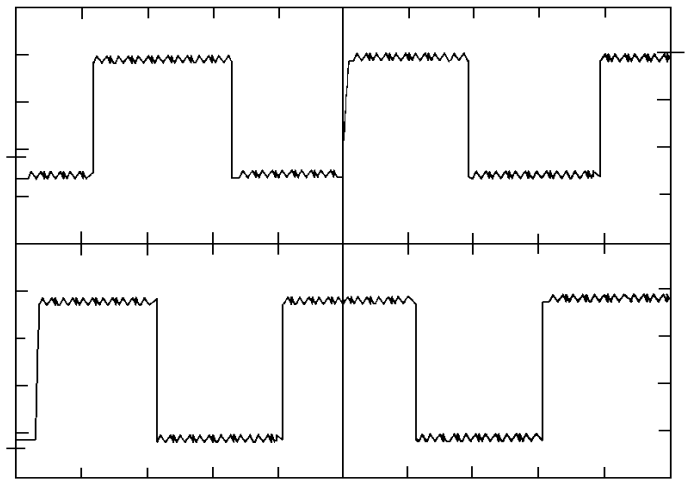
Figure 3.2
Waveform 2 - Encoder Phases A (TP15)
and B (TP12), Reverse (CW)

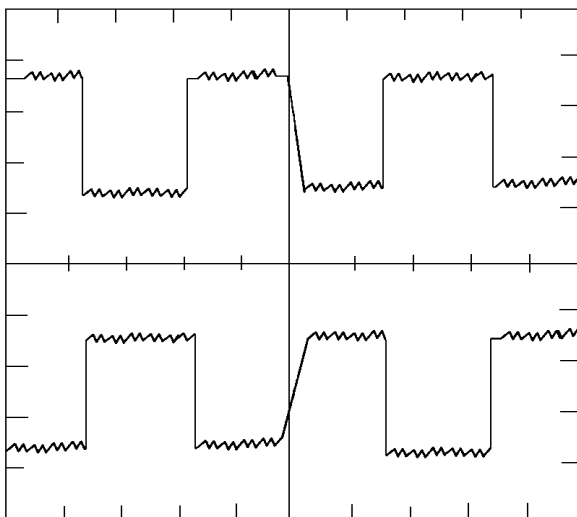
Figure 3.3
Waveform 3 - Encoder Signals A (TB3-20)
and A (NOT) (TB3-19)

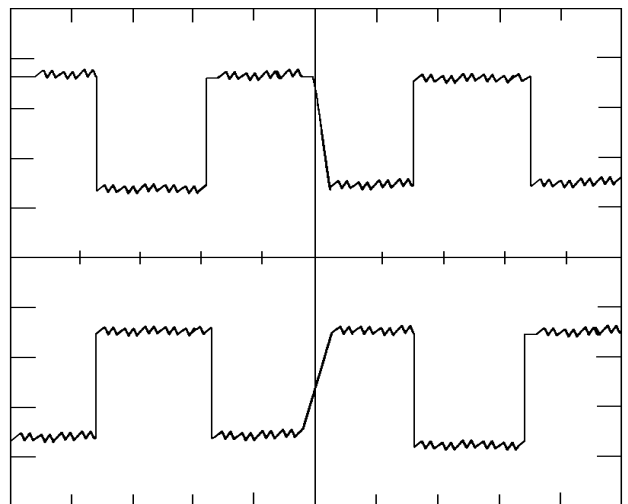
Figure 3.4
Waveform 4 - Encoder Signals B (TB3-18)
and B (NOT) (TB3-17)

Solution: Measure the encoder output signals at the 1395 terminal strip. Place a scope probe at TB3-17 and at TB3-18 and reference them to TE. These signals represent the differential channel outputs for phase B. TB3-17 is inverted and TB3-18 is non-inverted. Rotate the shaft of the motor, either by mechanical means or under armature voltage feedback control. The resulting waveform should be similar to Waveform 3. If the proper signal is not observed, replace the encoder. Note: If using armature voltage feedback to troubleshoot the encoder, the set-up procedure for armature voltage feedback must be performed first for proper operation. Use the same method to check phase A of the encoder output. Place a scope probe at TB3-19 and TB3-20 and reference them to TE. TB3-19 is inverted and TB3-20 is non-inverted. Rotate the shaft of the motor, either by mechanical means or under armature voltage feedback control. The resulting waveform should be similar to Waveform 3. If the proper signal is not observed, replace the encoder.

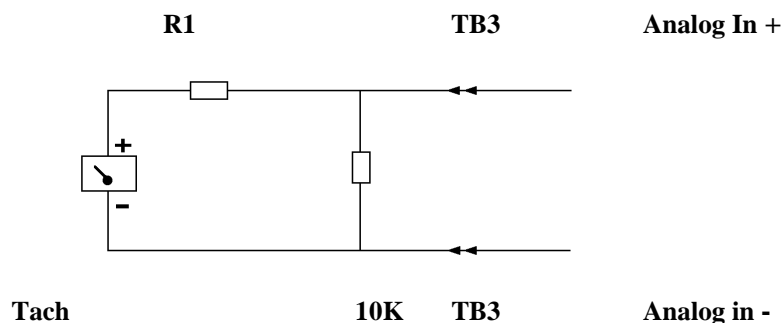
20K Adapter Board Input Impedance

This circuit uses a 10K resistor across the input channel and R1 represents the dropping resistor for the scaling network. To determine the value of R1 use the following equation:

$$\frac{(\text{Max Volts output}) \times 620}{9V} - 6250 = R1$$

1. Determine the Volts/RPM rating of the tach. It is usually on the tach nameplate. Multiply this rating times the absolute maximum speed the motor will be commanded to accelerate to. (This value should also be programmed in Parameter 607 “Rev Speed Lim” and 608 “Fwd Speed Lim” to ensure the velocity command will be properly clamped).
2. This Max Volts output must be scaled to a level within the +/- 10V analog input channel range. This can be accomplished by using a voltage divider that will take the Max Volts output and scale it to a maximum 9V input. This allows for protection against 10% overshoot.

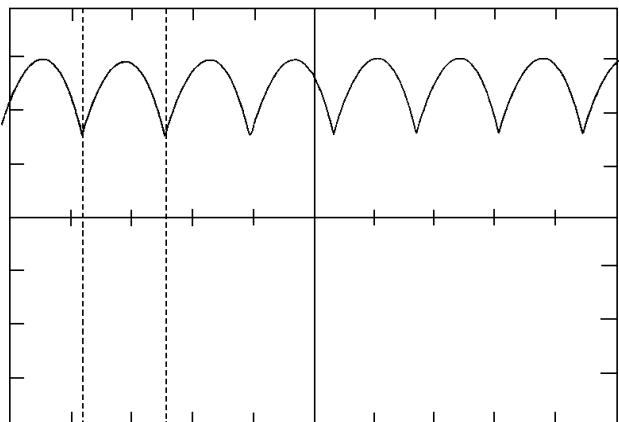
Figure 3.5
Waveform 5 - Armature Current Feedback
(TP2) - Continuous Current

TP21 - Armature Voltage Feedback is sensed at the output side of the DC contactor. It is scaled down to a +/- 10V signal and accurately reflects the voltage waveform across the motor armature. The waveform measured at TP21 is inverted in respect to the actual voltage across A1 to A2. Either an oscilloscope (preferred) or a DVM can be used to monitor this signal with respect to AGND (TP57). It is scaled on the low voltage drive (150- 300V DC) as 1V signal = 65V armature voltage. The high voltage drive (300-500V DC) is scaled as 1V signal = 125V armature voltage. The waveforms shown in Figures 3-5 through 3-11 represent the typical signal that occurs during the four quadrants of bridge operation.

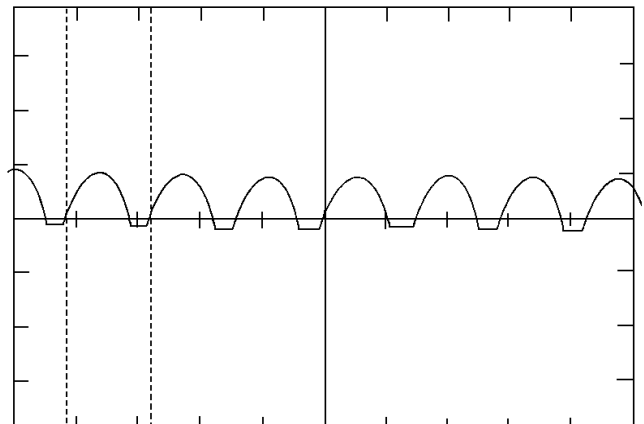
Figure 3.6
Waveform 6 Armature Current Feedback
(TP2) - Discontinuous Current

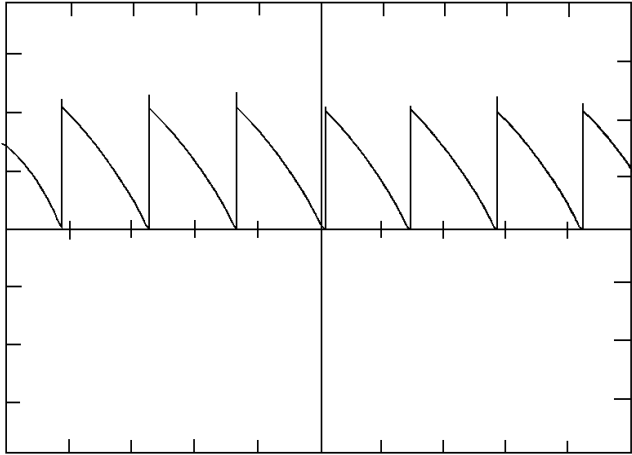
Figure 3.7
Waveform 9 - Armature Voltage Feedback
(TP21) - Motoring Forward

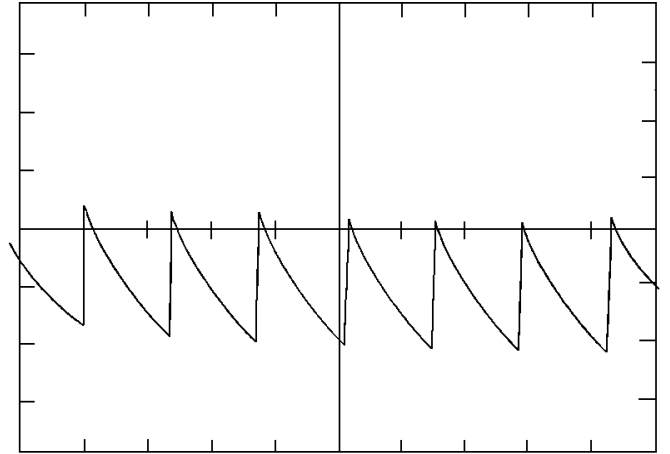
Figure 3.8
Waveform 8 - Armature Voltage Feedback
(TP21) Regen Forward

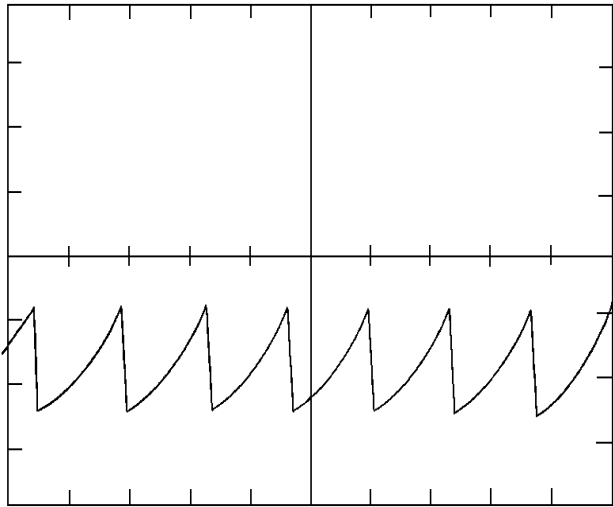
Figure 3.9
Waveform 7 - Armature Voltage Feedback
(TP21) Motoring Reverse

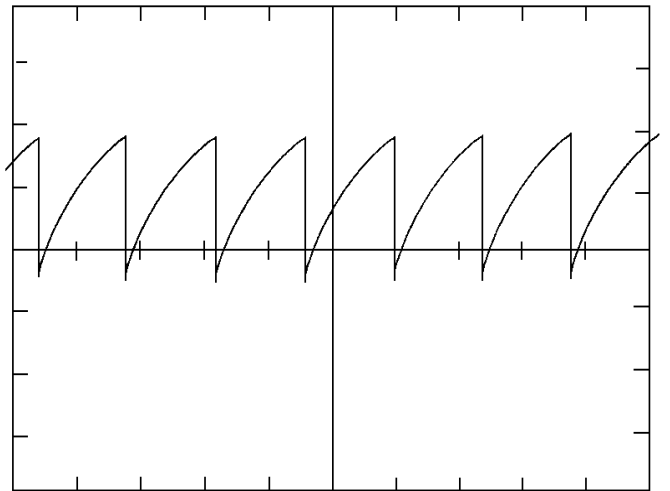
Figure 3.10
Waveform 10 - Armature Voltage Feedback
(TP21) Regen Reverse

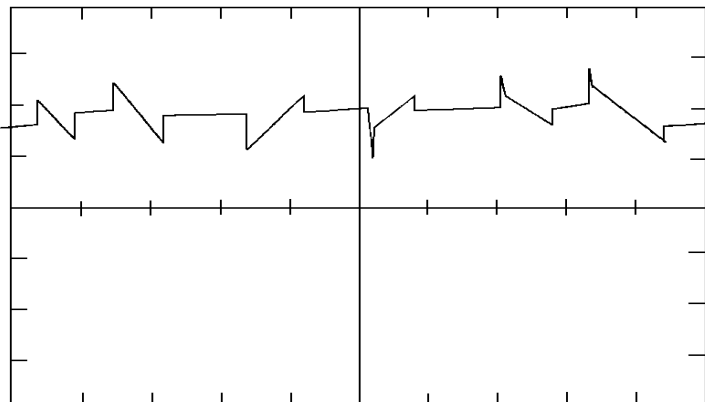
Figure 3.11
Waveform 11 - Armature Voltage Feedback
(TP21) Constant Velocity w/No Load

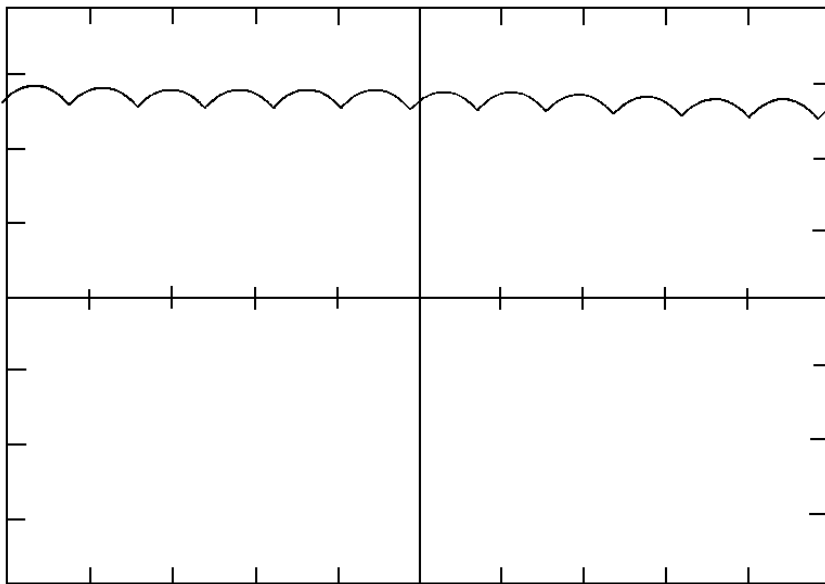
Figure 3.12
Field Current Feedback (TP25) - Continuous Current

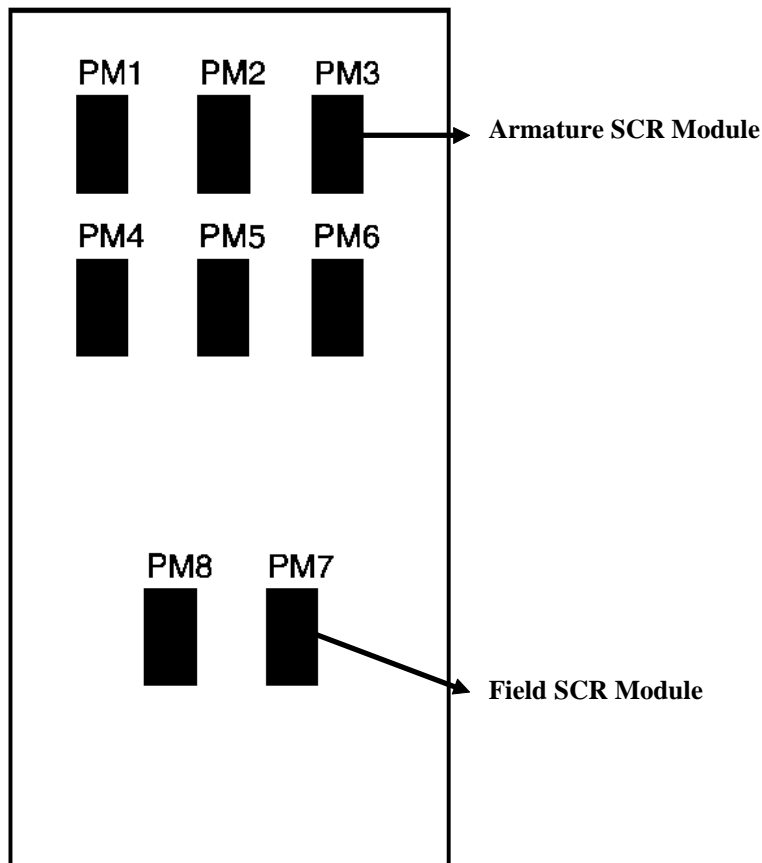
SCR Layout Series A

- PM1 - Upper left SCR module;
A1 (Bottom of DC contactor) to L1 (bottom of F1)
- PM2 - Upper middle SCR module;
A 1 (bottom of DC contactor) to L2 (bottom of F2)
- PM3 - Upper right SCR module;
A1 (bottom of DC contactor) to L3 (bottom of F3)
- PM4 - Lower left SCR module;

All resistance's should be 100kohms or greater. If a low resistance is detected replace the affected SCR pack.

All resistance's should be between 7 to 30 ohms. If a measurement is outside of this range or if one reading deviates significantly from the majority, then module replacement may be necessary.

1. Disconnect and lock-out ALL incoming voltage sources. Verify that the three-phase high voltage is removed from the incoming protection devices, either F1 - F3 or the main circuit breaker CB1. Also verify that the 115V logic supply and contactor power is removed from TB2-3,4, and 5. If an external field supply is used, verify that it is also removed by checking TB1-1 and 5.
2. Check the Anode to Cathode junction of each SCR module. With a DVM on the 1 Meg ohm scale, measure the resistance across the SCR modules as follows: (Note: Lead orientation is not critical)

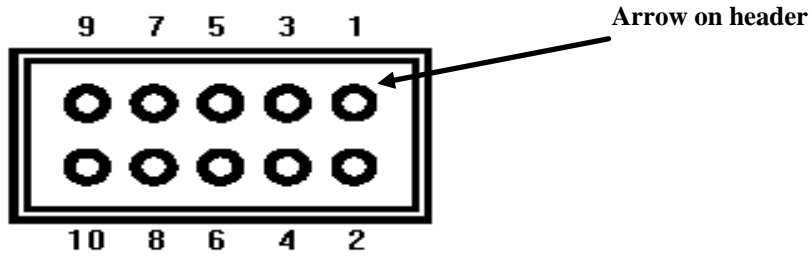
J1 Pin Orientation (Top View)

G1 (upper) to DCA1 should be 100 ohms +10%
G1 (lower) to DCA2 should be 100 ohms +10%
G2 (upper) to AC (2L1) should be 100 ohms +10%
G2 (lower) to AC (3L1) should be 100 ohms +10%
D1 (anode) to DCA1 should be 1 to 2 ohms
D2 (anode) to AC (2L1) should be 1 to 2 ohms
D3 (anode) to AC (3L1) should be 1 to 2 ohms
D4 (anode) to DCA2 should be 1 to 2 ohms
J1-1 to J1-8 should be 100 ohms +10% (see below)
J1-2 to J1-8 should be 100 ohms +10% (see below)
J1-3 to J1-8 should be 100 ohms +10% (see below)
J1-6 to J1-8 should be 100 ohms +10% (see below)

3. If any of these measurements (G1 through J6) are out of tolerance, replace the associated board. If these procedures check out and no apparent discrepancies are found, a potential problem could still exist. If a “breakdown path” has been established from the pulse transformer primary to secondary, it is possible that a malfunction could show itself when the line voltage potential is applied to the power structure. This condition can only be detected by “hi potting” the board at a level of 2500Vrms, and verifying less than 5mA from primary to secondary.

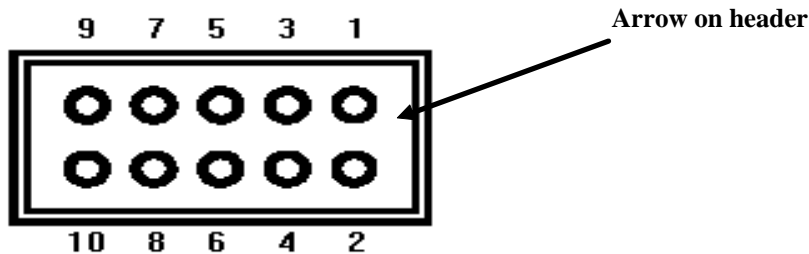
J1 Pin Orientation (Top View)

L1 to D3 (cathode) should be 100 ohms +/- 10%
L1 to D3 (anode) should be 1 to 2 ohms
F1 to D4 (cathode) should be 100 ohms +/- 10%
F1 to D4 (anode) should be 1 to 2 ohms
L3 to D2 (cathode) should be 100 ohms +/- 10%
L3 to D2 (anode) should be 1 to 2 ohms
F1 to D1 (cathode) should be 100 ohms +/- 10%
F1 to D1 (anode) should be 1 to 2 ohms
J1 - 1 to J1-9 should be 60 ohms +/- 10%
J1 - 1 to J1-10 should be 60 ohms +/- 10%

If any of these measurements are out of tolerance, replace the associated board. If the above procedure checks out and no apparent discrepancies are found, a potential problem could still exist. If a “breakdown path” has been established from the pulse transformer primary to the secondary, it is possible that a malfunction could show itself when the line voltage potential is applied to the power structure. This condition can only be detected by “hi potting” the board at a level of 2500V rms, and verifying less than 5mA from primary to secondary.

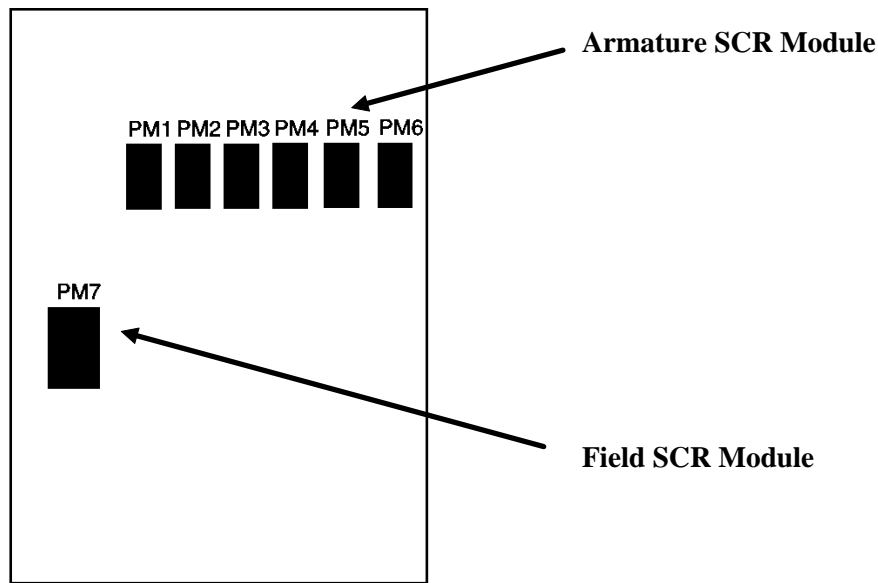
PM1 - left SCR module; to PM2 2nd SCR module
 A1 (bottom of DC contactor) to L1 (bottom of F1)
 A2 (bottom of DC contactor) to L1 (bottom of F1)
 PM3 - 3rd SCR module to PM4 4th SCR module
 A1 (bottom of DC contactor) to L2 (bottom of F2)
 A2 (bottom of DC contactor) to L2 (bottom of F2)
 PM5 - 5th SCR module to PM6 Right SCR module
 A1 (bottom of DC contactor) to L3 (bottom of F3)
 A2 (bottom of DC contactor) to L3 (bottom of F3)

All resistance's should be 100K ohm or greater. If a low resistance is detected, remove the power board and determine which of the power module pair is bad, replace it accordingly.

All resistance's should be between 7 to 30 ohms. If measurement is outside of this range or one reading deviates significantly from the majority, module replacement may be necessary.

1. Disconnect and lock-out ALL incoming voltage sources. Verify that the three-phase high voltage is removed from the incoming protection devices, either F1 - F3. Also verify that the 115V logic supply and contactor power is removed from TB2-1, 2, 3. To gain access to the Power Board, swing down and remove PS1/Switcher Board.
2. Check the Anode to Cathode junction of each SCR module. With a DMM on the 1 Megohm scale, measure the resistance across the SCR modules as follows:
