PowerFlex 400 Drive Firmware Release Number (FRN) 6.01

This release note corresponds to FRN 6.01 for the PowerFlex 400 drive.

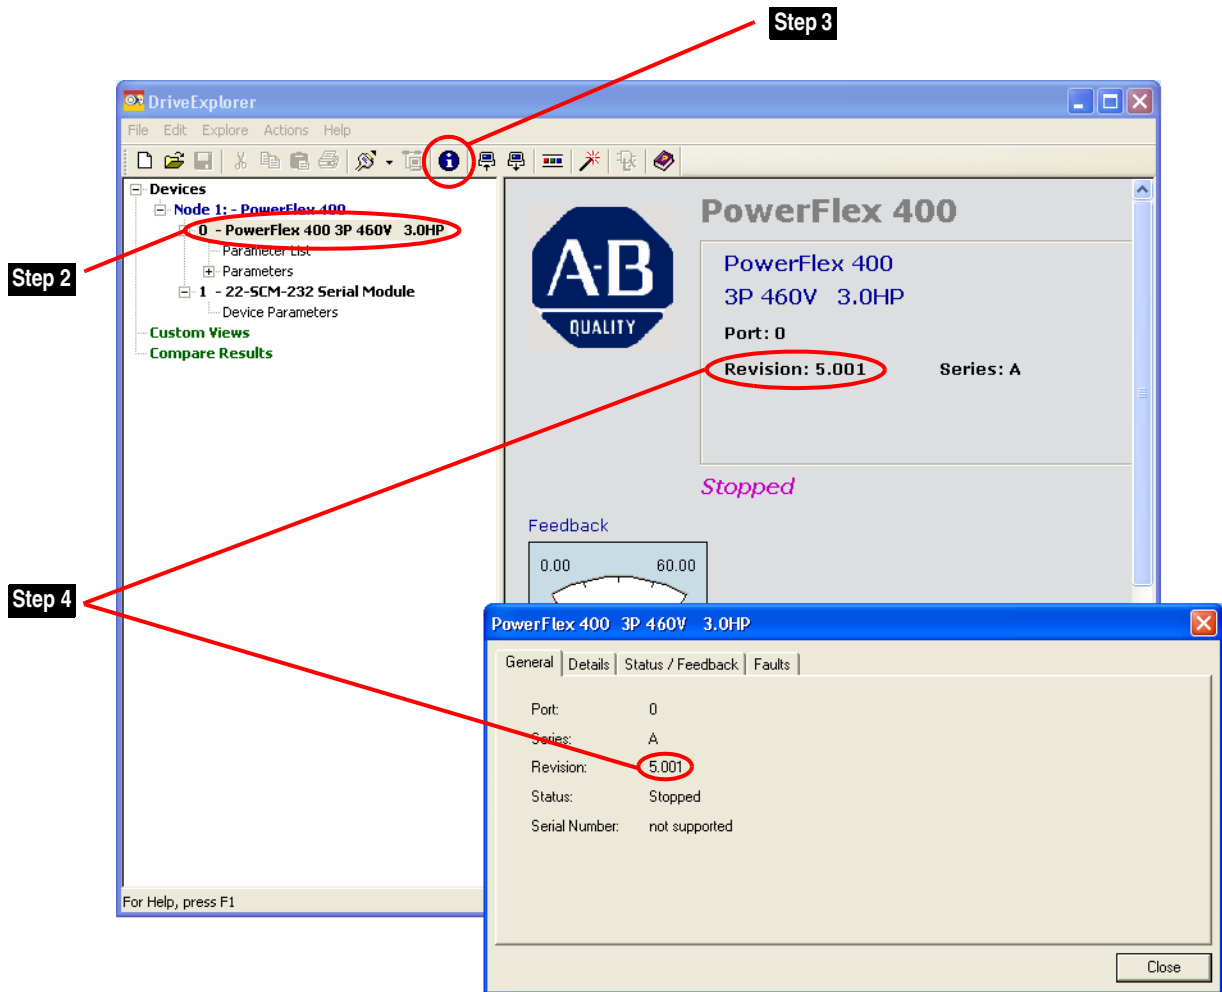
Figure 1 Using DriveExplorer to determine current firmware revision

1. Launch DriveExplorer and go online with the drive via the 1203-USB or 22-SCM-232 converter.
2. In the DriveExplorer tree view, click the PowerFlex 400 item as shown in [Figure 1](#).
3. Click the information icon to display the Properties screen of the drive.

▶ **TIP:** When you click the PowerFlex 400 item in DriveExplorer Lite/Full version 5.01 or higher, the adapter firmware revision is also shown in the right pane of the DriveExplorer window.
