## **PowerFlex<sup>®</sup> 755 Drives (revision 2.011)**

These release notes correspond to major revision 2, minor revision 11 of firmware for PowerFlex<sup>®</sup> 755 drives.

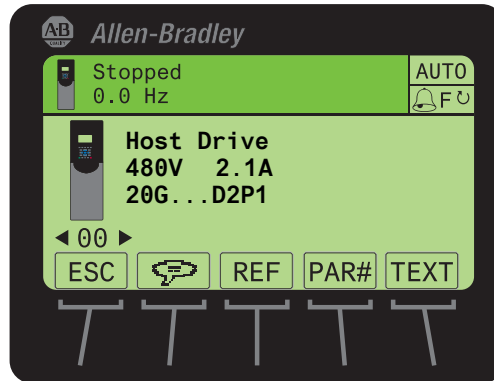
Figure 1 Status Screen

1. Access the Status screen, which is displayed on HIM power up.

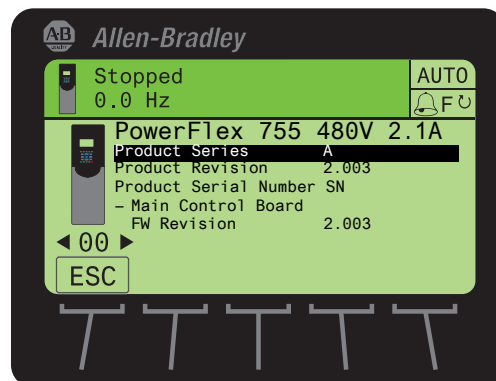
Figure 2 Device Version Information Screen

FW Revision is listed under –Main Control Board; see [Figure 2](#).

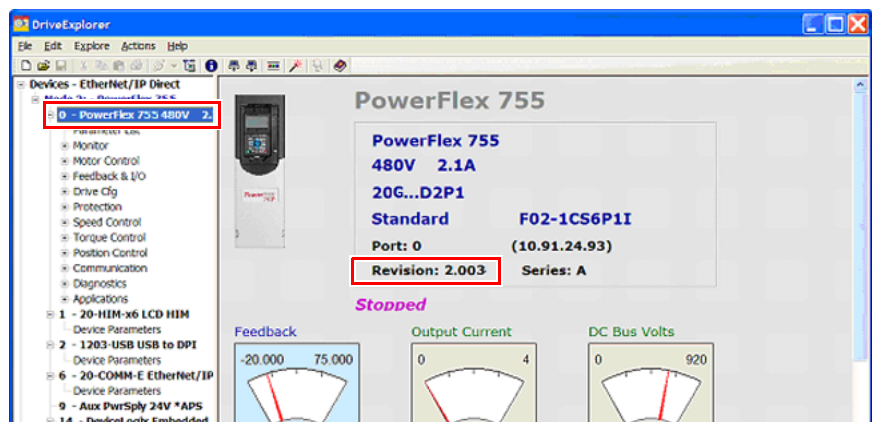
1. Launch DriveExplorer and go online with the PowerFlex 755 drive. To connect to the drive, use a 1203-USB converter, a 1203-SSS converter, or an EtherNet/IP network connection.
2. In the Devices hardware view, select the PowerFlex 755 drive.

Once selected, information regarding the PowerFlex 755 drive is shown in the right panel including the current firmware revision number.

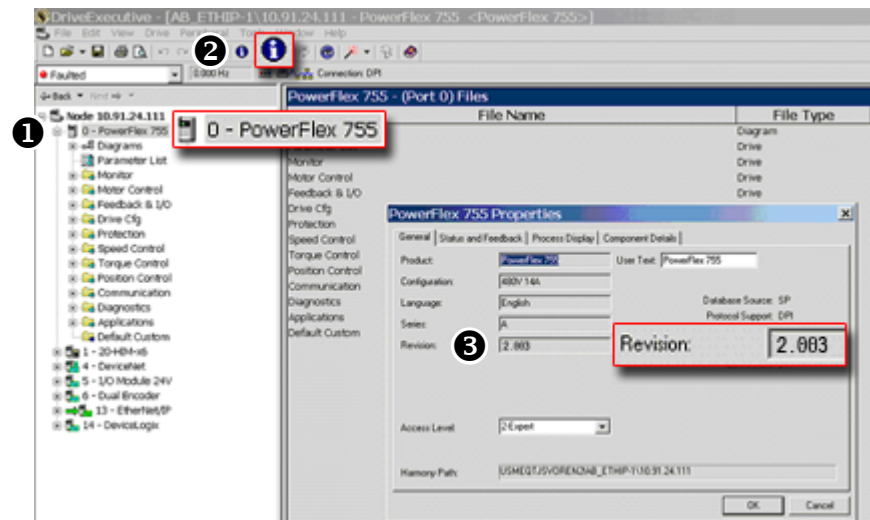
Figure 3 Accessing the PowerFlex 755 Drive Firmware Revision Number

1. Launch DriveExecutive and go online with the PowerFlex 755 drive. To connect to the drive, use a 1203-USB converter, a 1203-SSS converter, or an EtherNet/IP network connection.
2. In the Drives hardware view, select the PowerFlex 755 drive (❶ in [Figure 3 on page 4](#)).
3. Click the information icon (❷ in [Figure 3](#)) to display the drive's Properties dialog box.

In the Properties dialog box the “Revision:” field (❸ in [Figure 3](#)) will show the drive's current firmware revision number.

1. With the Flash Kit installed (see [Installing the Flash Kit](#)), launch DriveExecutive and go online (via a 1203-USB or 1203-SSS converter) with the PowerFlex 755 drive.
2. In the Drives hardware view, select the PowerFlex 755 drive (❶ in [Figure 3 on page 4](#)).
3. Click the information icon (❷ in [Figure 3](#)) to display the drive's Properties dialog box.
4. In the Properties dialog box, click the Component Details tab (❸ in [Figure 3](#)).
5. With the PowerFlex 755 drive selected, click **Flash Update**.

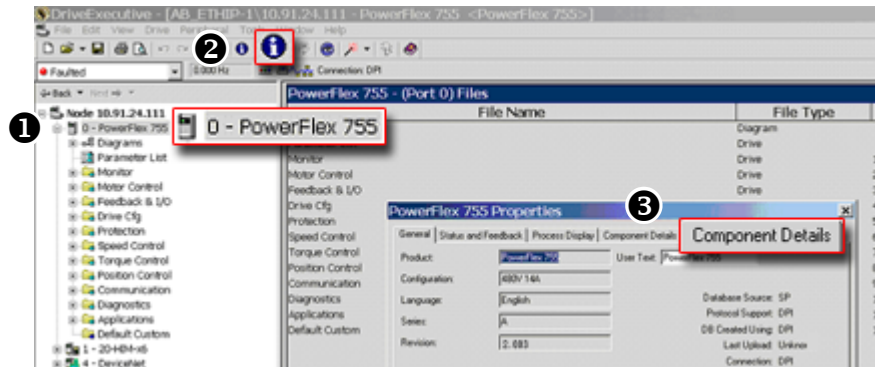
Figure 4 Accessing the Component Details Tab of the Properties Dialog Box

1. With the Flash Kit installed (see [Installing the Flash Kit](#)), launch DriveExecutive and go online (via a 1203-USB or 1203-SSS converter) with the PowerFlex 755 drive.
2. In the Devices hardware view, select the PowerFlex 755 drive (1 in [Figure 4](#)).
3. Click the information icon (2 in [Figure 4](#)) to display the drive's Properties dialog box.

4. In the Properties dialog box, click the Component Details tab (3 in Figure 4).

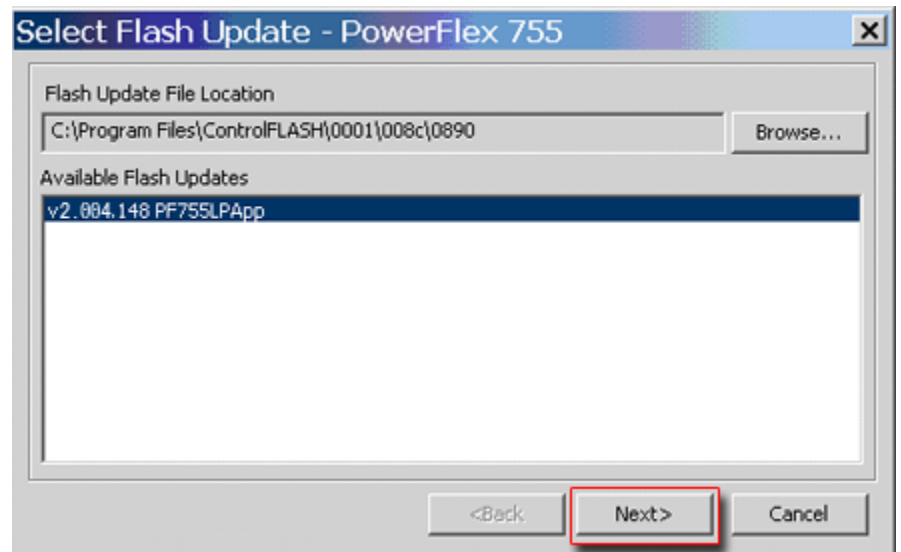
6. From the list of available updates, select “v2.011.xxx” and click **Next >**.

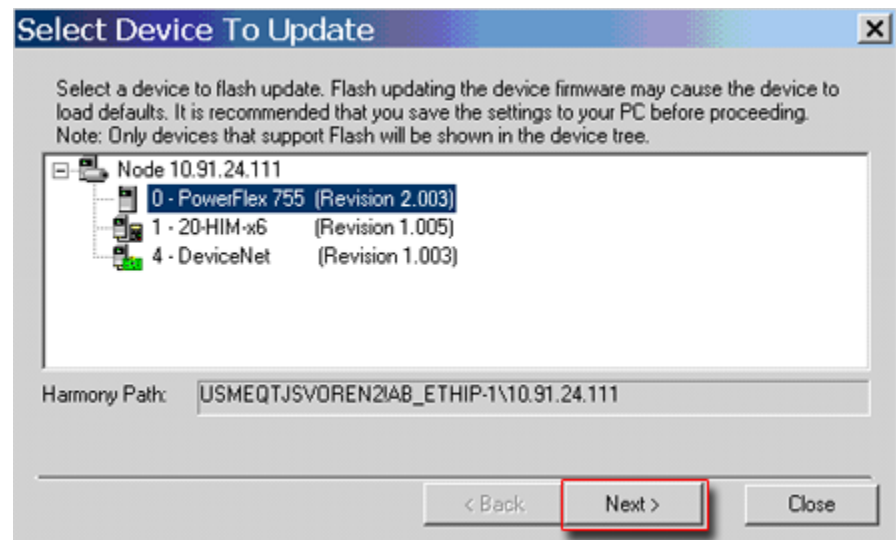
6. From the list of available devices, select the PowerFlex 755 drive and click **Next >**.

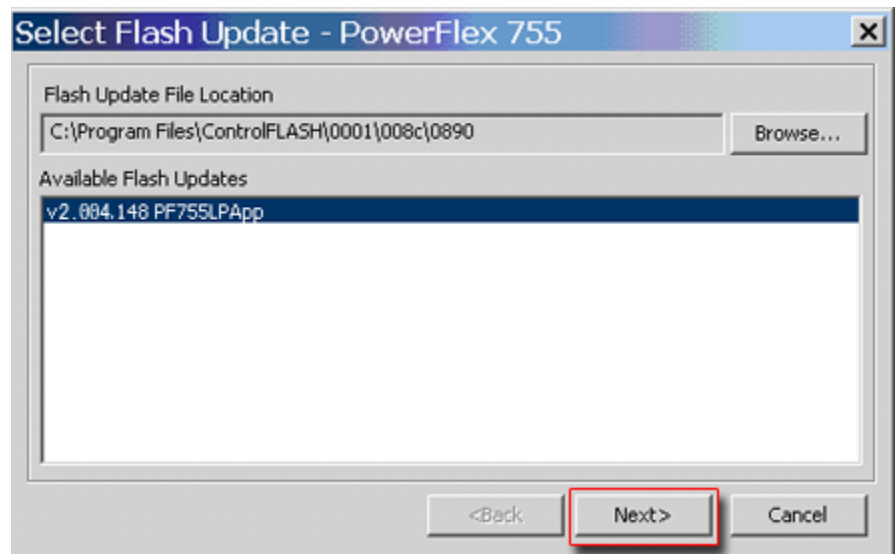
7. From the list of available updates, select “v2.011.xxx” and click **Next >**.

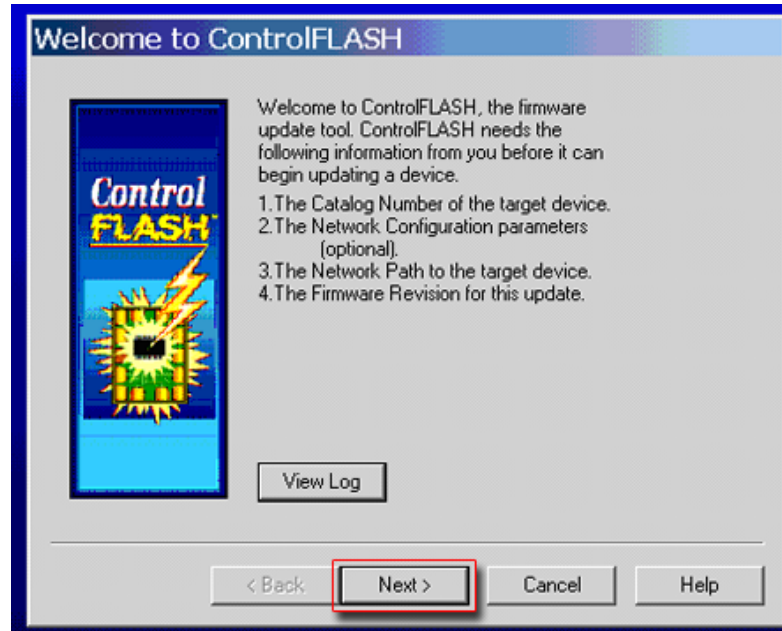
1. With the Flash Kit installed (see [Installing the Flash Kit on page 4](#)), launch ControlFLASH by selecting **Start > (All) Programs > Flash Programming Tools > ControlFLASH**.
2. On the ControlFLASH Welcome screen, click **Next >**.

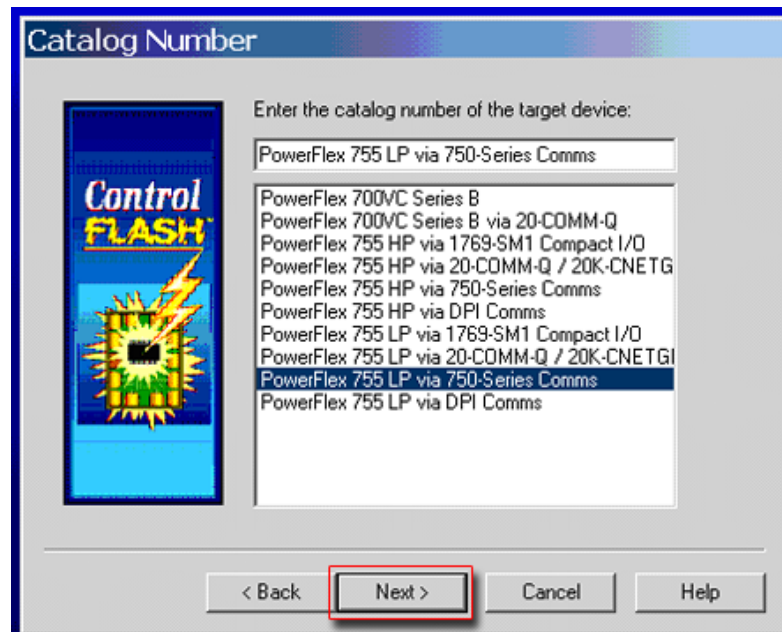
3. The Catalog Number dialog box appears. From the list, choose the communication device you will use to update the PowerFlex 755 drive. In the figure below, the embedded EtherNet device is selected.

Once the appropriate communication device is selected, click **Next >**.

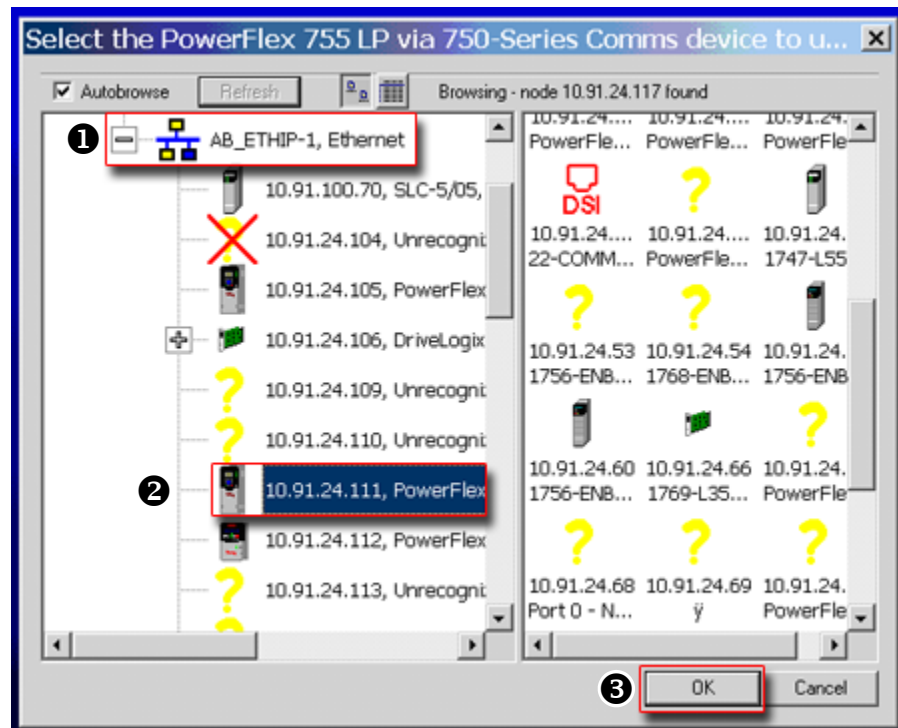
Figure 5 Selecting the Correct Drive to Flash

4. Now that the correct communication device has been selected, you must select which device is being updated. With the Select the PowerFlex... dialog box displayed, follow these steps.
  - a. Expand the hardware view for the communication path you are using (❶ in [Figure 5](#)).
  - b. Select the drive icon that represents the PowerFlex 755 drive you are updating (❷ in [Figure 5](#)).
  - c. Click OK (❸ in [Figure 5](#)).

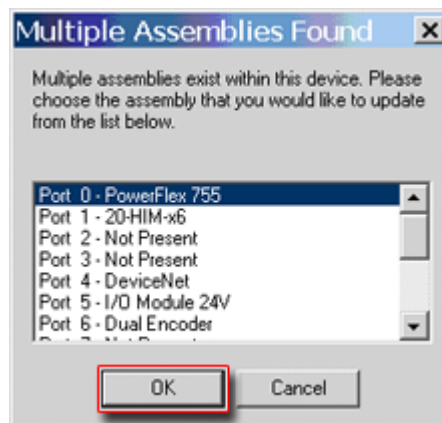
5. In the Multiple Assemblies Found display box, select “Port x-PowerFlex 755” from the list and click OK.

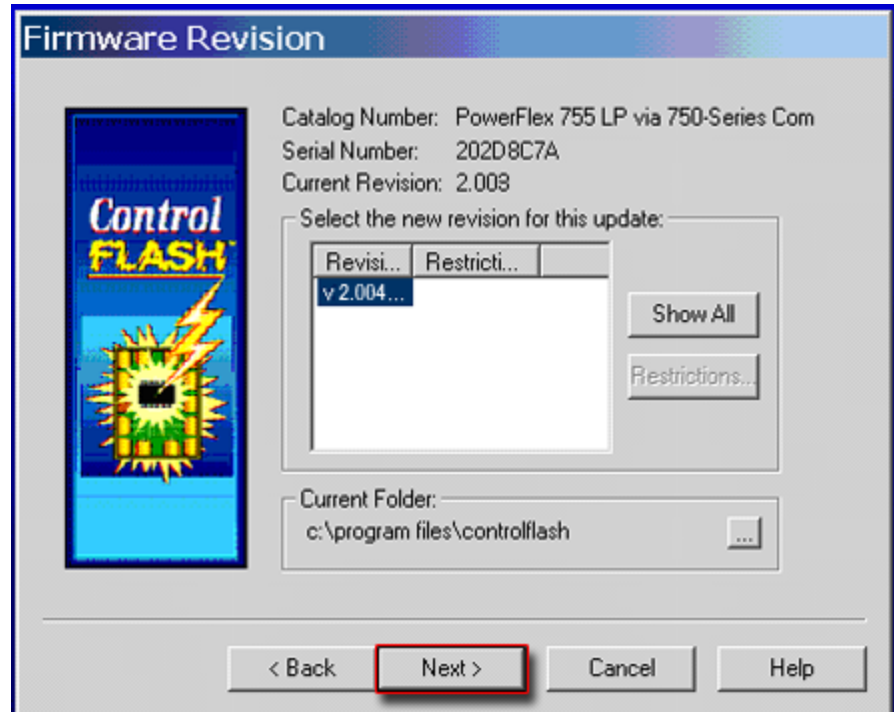
- In the Firmware Revision dialog box, select “v2.011...” from the list of available updates and click **Next >**.

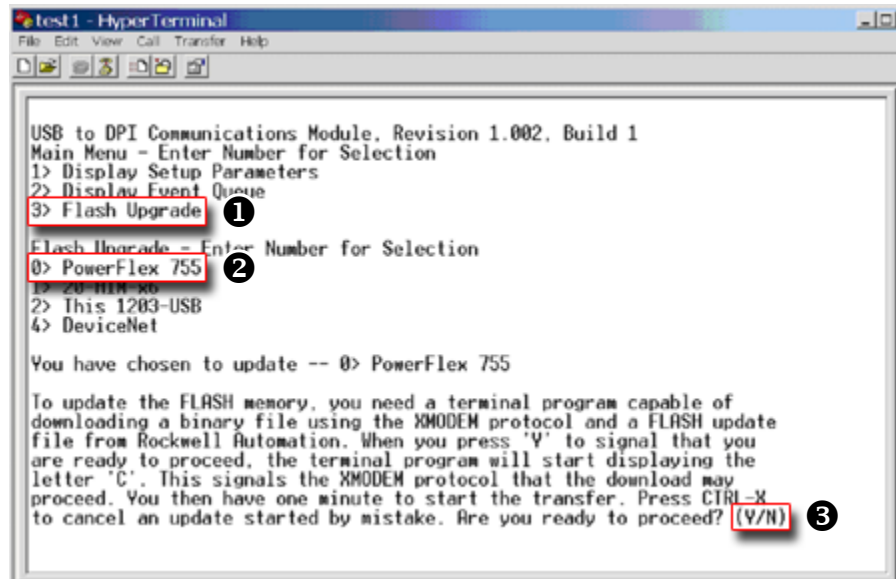
Figure 6 HyperTerminal Test Screen Dialogue

6. From the Main Menu, select the flash upgrade (❶ in [Figure 6](#)) by pressing the number **3** key on your computer keyboard.
7. Additional text appears. From the Flash Upgrade menu, select the PowerFlex 775 drive (❷ in [Figure 6](#)) by pressing the number **0** key on your computer keyboard.
8. Additional text appears. After reading the conditions, select Yes (❸ in [Figure 6](#)) to proceed by pressing the letter **Y** key on your computer keyboard.

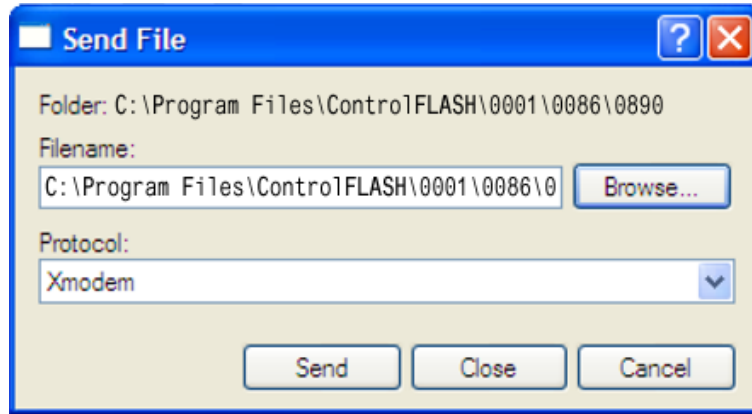
11. Search within the appropriate subfolder until the “PF755\_LP\_App\_v3\_004\_xxx.dpi” file appears in the Select File to Send list.
12. With the file name highlighted, click **Open** so it appears in the Filename data field in the Send File dialog box.

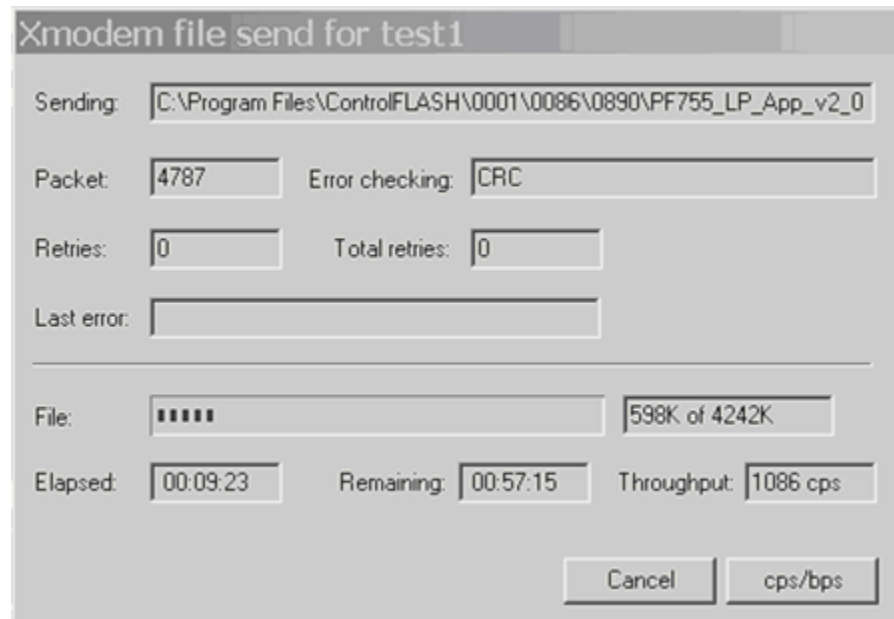
A dialog box appears and reports the update progress, which **takes about one hour for HyperTerminal to complete**. When it is complete, the message “Flash Complete” appears.
